Hudson River Estuary Watershed Assessment & Outreach Project

**2007 Watershed Report Card for Krumkill Watershed**

A Hudson Basin River Watch Watershed Assessment & Outreach Project

**Krumkill Watershed**

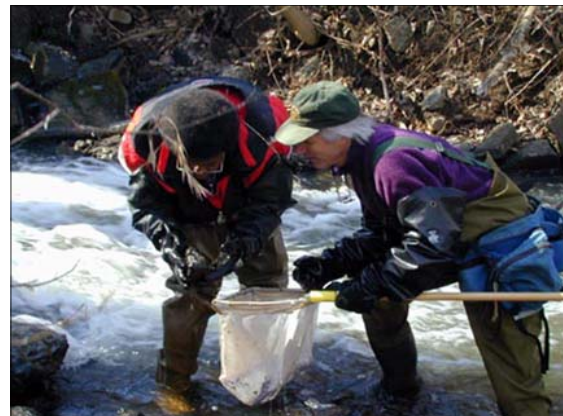
The NYS DEC Stream Biomonitoring Unit's (DEC SBU) methodology was used for all sample collection and analysis tasks. These methods involve collecting, sorting and analyzing a sample of benthic macroinvertebrates (stream bottom-dwelling organisms with no backbone that are visible to the naked eye). These organisms vary in their sensitivity to water quality impacts. DEC SBU's methods use the presence or absence, relative abundance, and diversity of species to obtain an overall water quality score called the Biological Assessment Profile (BAP). BAP is scored 0-10, with 10 indicating the best water quality. The DEC SBU also uses four narrative descriptions of water quality based on the BAP score as illustrated in this graph:

It's important to note that the term "slightly impacted" can be misleading if it's taken out of context. Sites with water quality at only 5.1 on the BAP scale, or almost "moderately impacted", can be described as only "slightly impacted".
